BALCONY & STAIR INSPECTION

SUMMIT YACHT CLUB

June 30, 2019

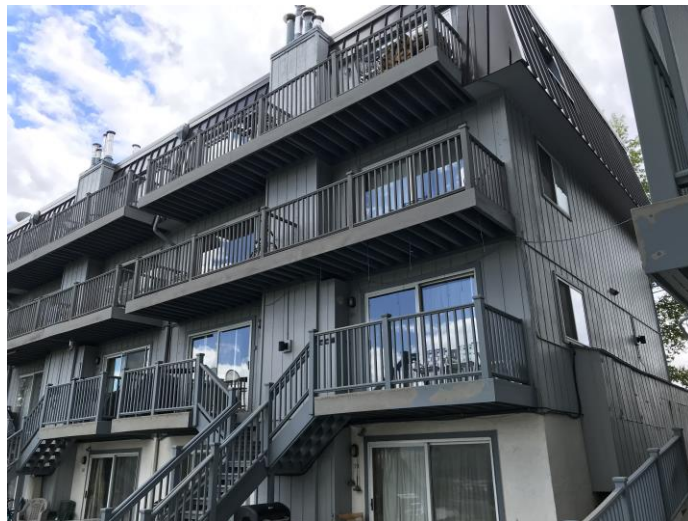
3 level Deck view

The decks and stairs are similar in construction on all buildings and appear to be original construction to the buildings. The lower level of decks are accessed by stairs from the ground. The upper level decks are accessed from the individual units.

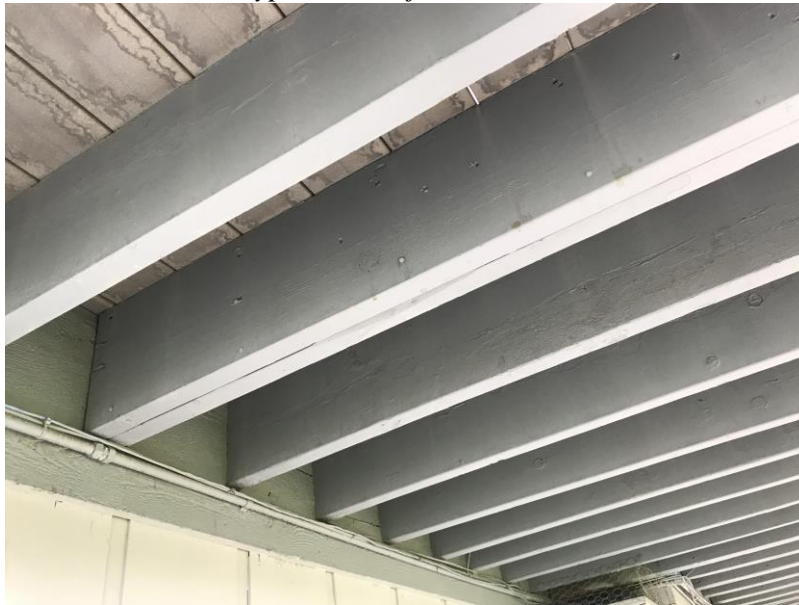
Typical deck joists

- No rot was observed on the top of the deck joists where rot typically forms. Double joists on the outer edge of the deck are both load bearing. Double joists on the internal structure of the deck have one load bearing joist and one sistered joist.

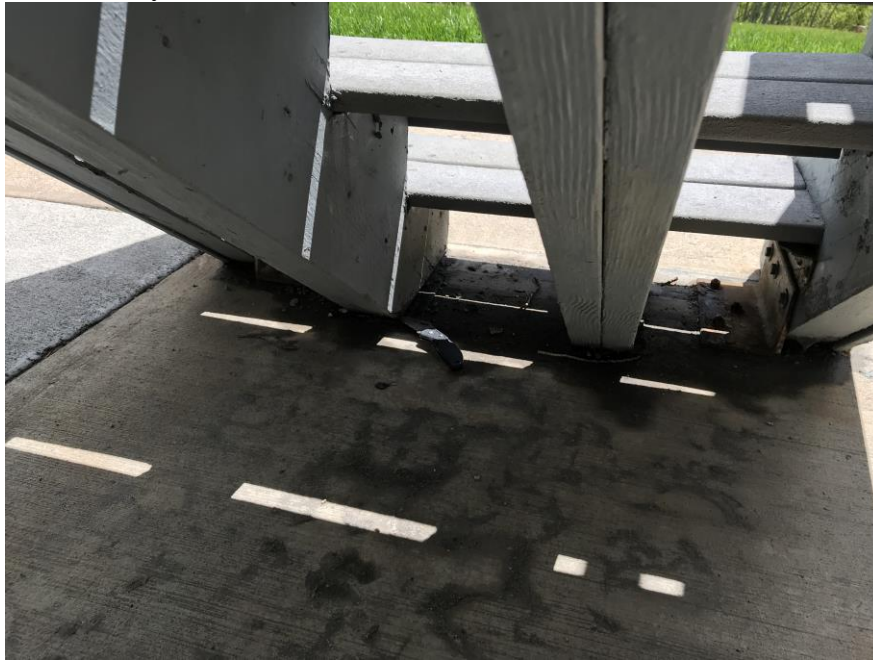
- Wooden stair stringers are in good condition except for the bottom of the stringer which is in contact with the cement slab on grade. Some early rot development observed at this location with 1/8" knife penetration. The concrete slab appears to be stable without any visible settlement.

The deck structure is in good condition with the exception of the bottom of the stair stringer which is in contact with the concrete slab. Monitor this area annually for rot progression and repair when there is any movement of the stair stringer. Recommend cutting the rotted section of the stringer off horizontally and supporting stringer off steel angle so that no wood is in contact with the concrete slab.

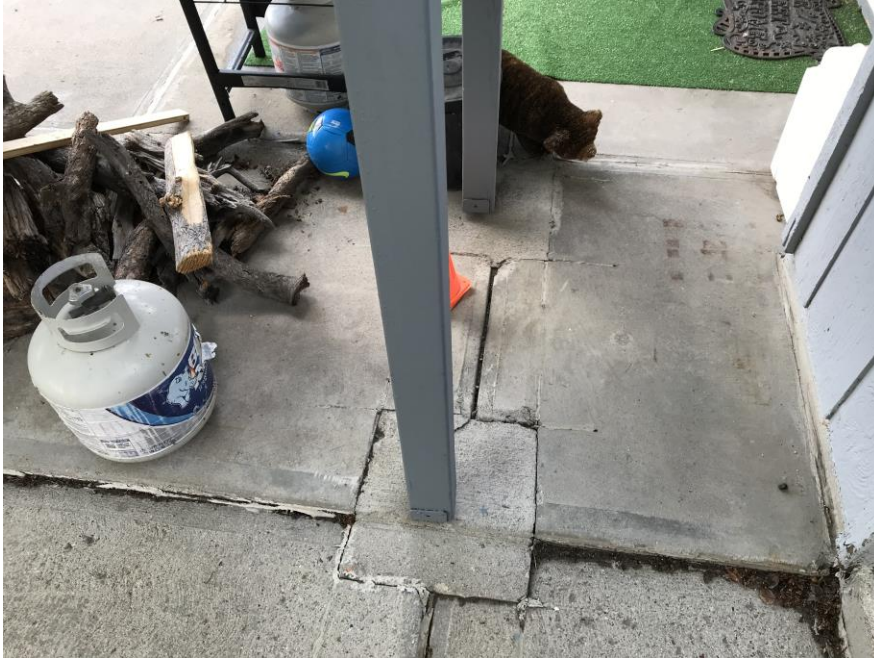
- 4x4” support posts for stairs have elevated base above the concrete to minimize moisture penetration and these are in good condition. The concrete base is a pier of unknown depth.

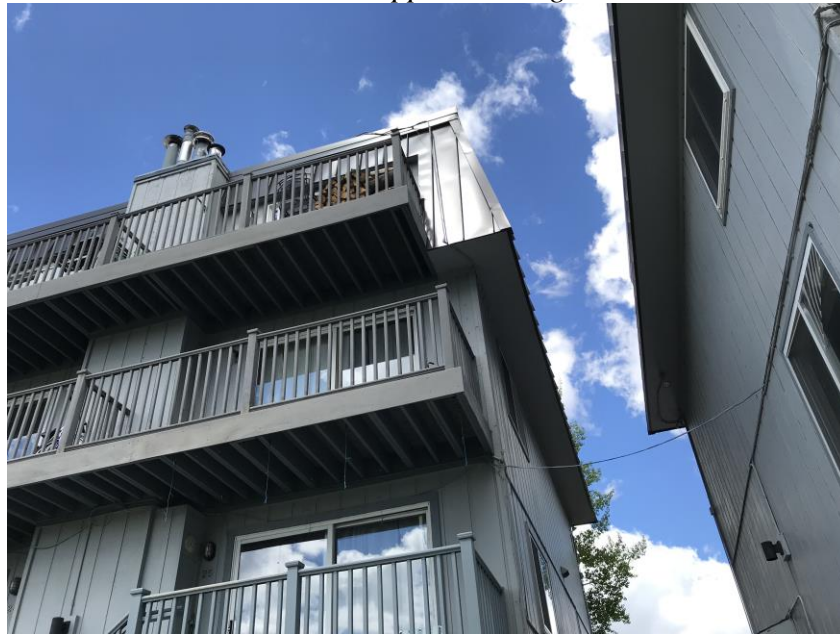
Firewood on upper deck-right side

- Firewood is stored on some of the decks with up to two piles of firewood 6 ft.x 3ft x 3ft. approx. piles observed.

FireWood load (Oak) - 6 ft x 3 x3 @ 45#/ft³= 2430 # for an assumed load of 810#/joist

The original design conditions for these decks for snow+ dead+ live load is approx. 700#/joist.

Assume the worst-case situation for a loaded deck joist with firewood plus a full snow load and there is the potential for a joist failure at 1400#/joist (200% of design load listed above). A single joist failure would most likely occur on the top-level deck and cascade to lower decks. This could lead to structural damage to the building and possible injury or loss of life.

Recommend that firewood on decks be prohibited for this property.

The other option if firewood is to remain on the decks is to install new support columns down to grade level with new concrete piers to increase the capacity of the decks to support load.
